# An Update of *Historic* *Proportions*

## A COMPLEX ACCESS SYSTEM EASES THE RENOVATION OF ONE OF AMERICAN HISTORY'S MOST PROMINENT BUILDINGS

By Vincent Brennan;  
Photos by Erik Highland

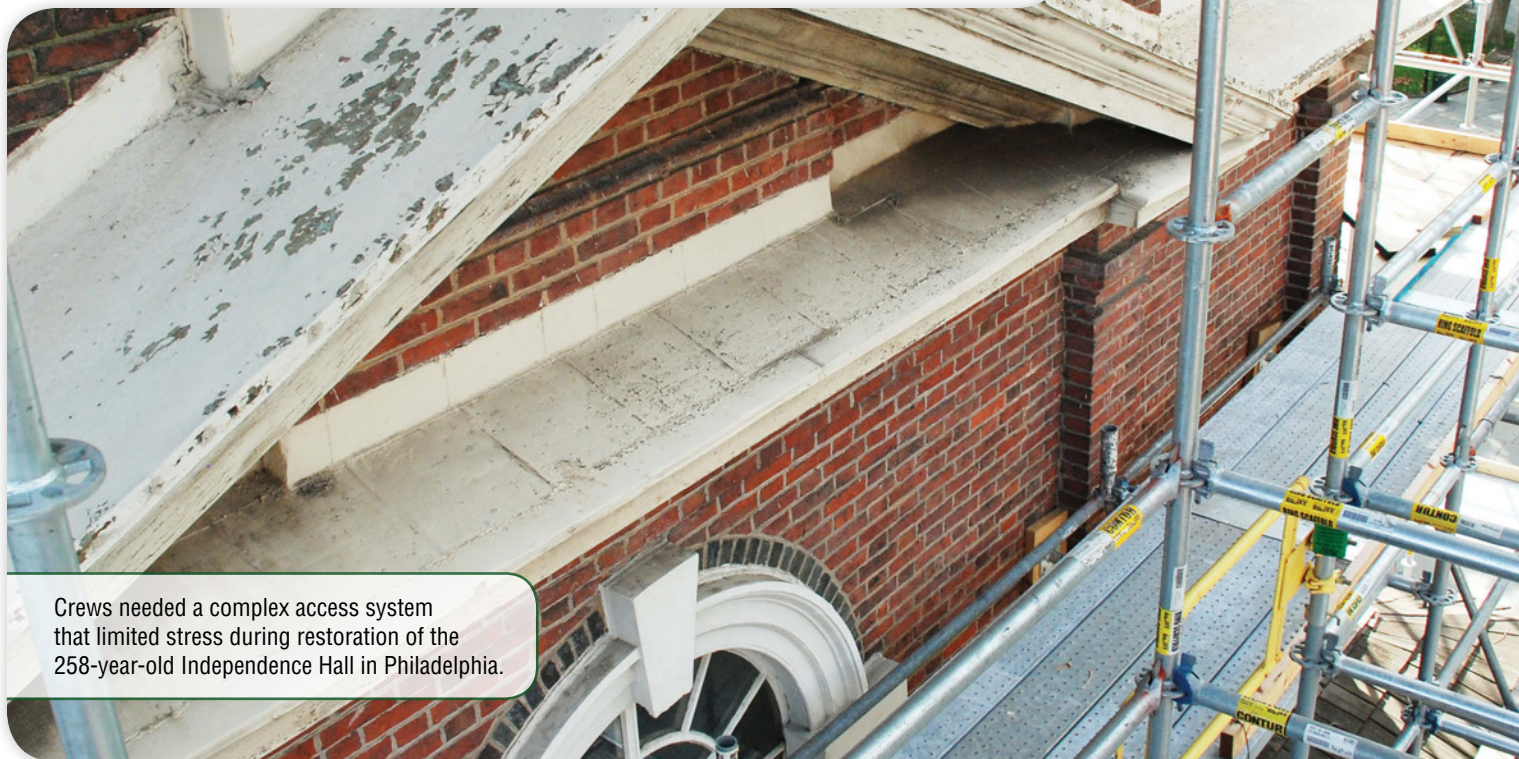
Crews needed a complex access system that limited stress during restoration of the 258-year-old Independence Hall in Philadelphia.

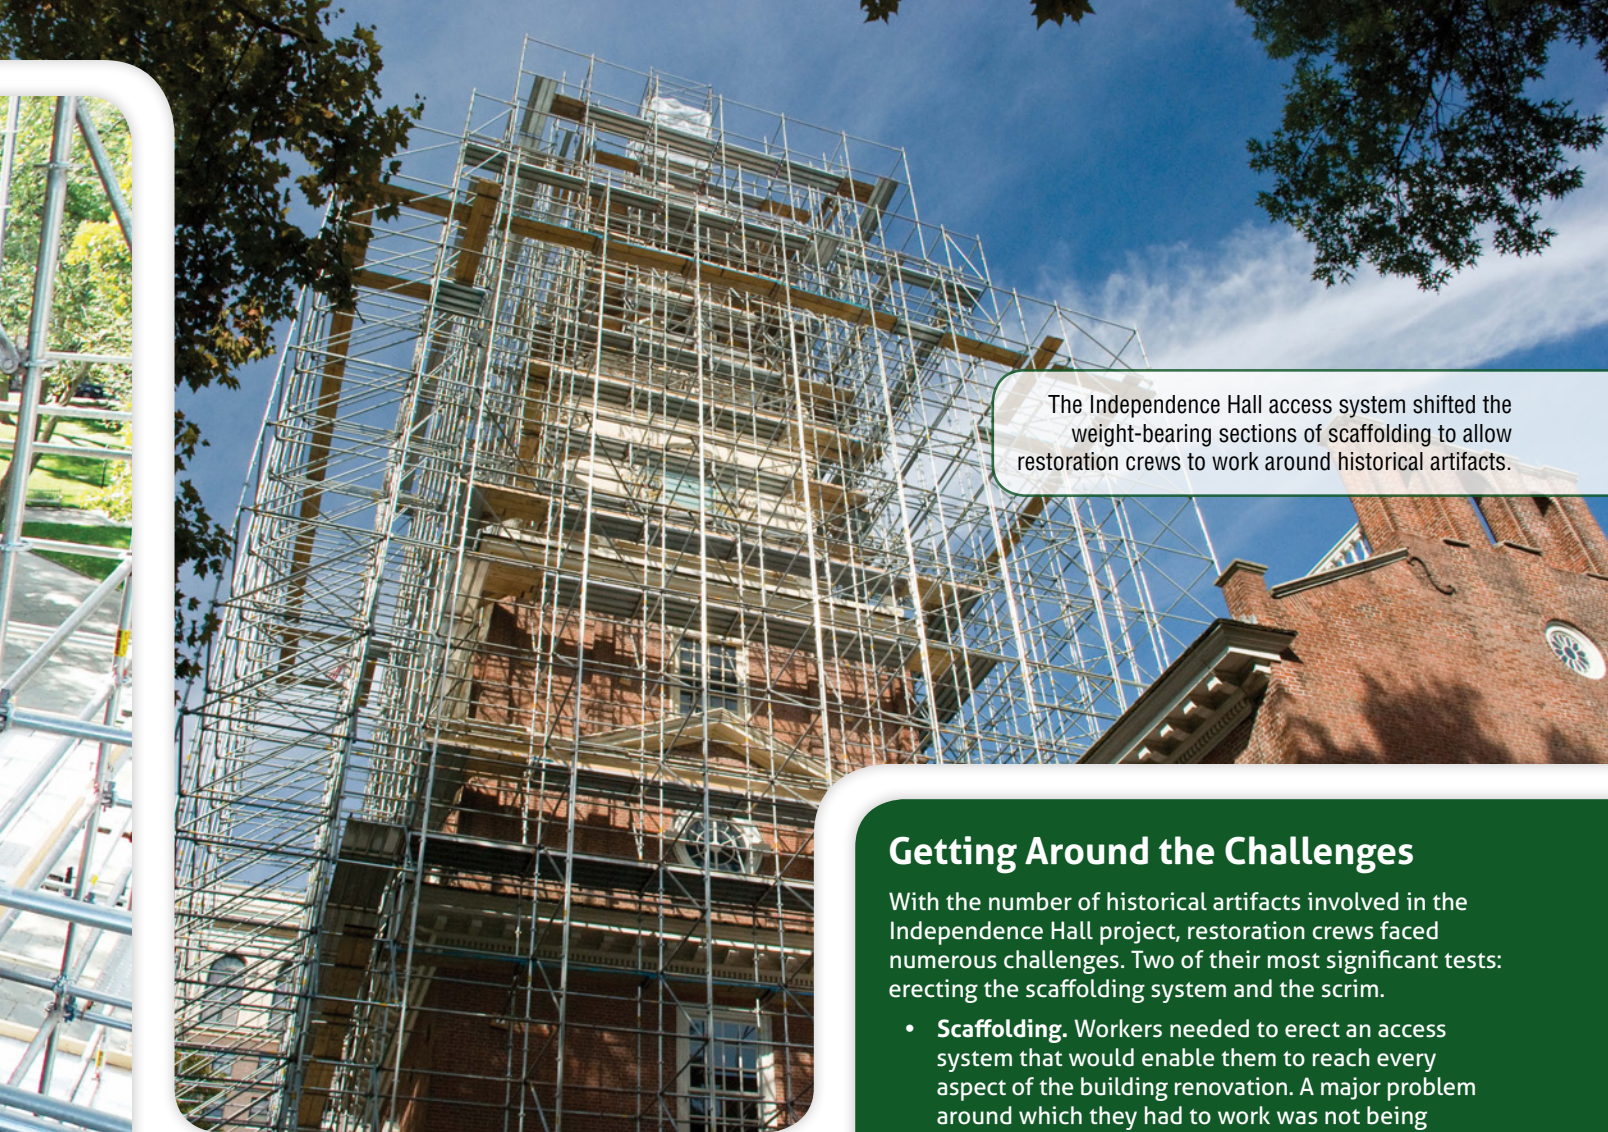
The Independence Hall access system shifted the weight-bearing sections of scaffolding to allow restoration crews to work around historical artifacts.

- **Scaffolding.** Workers needed to erect an access system that would enable them to reach every aspect of the building renovation. A major problem around which they had to work was not being able to move or remove priceless artifacts, such as copper urns. Leaving those items in place, then, crews had to shift the weight-bearing sections of scaffolding to allow access where usually they would have had none.

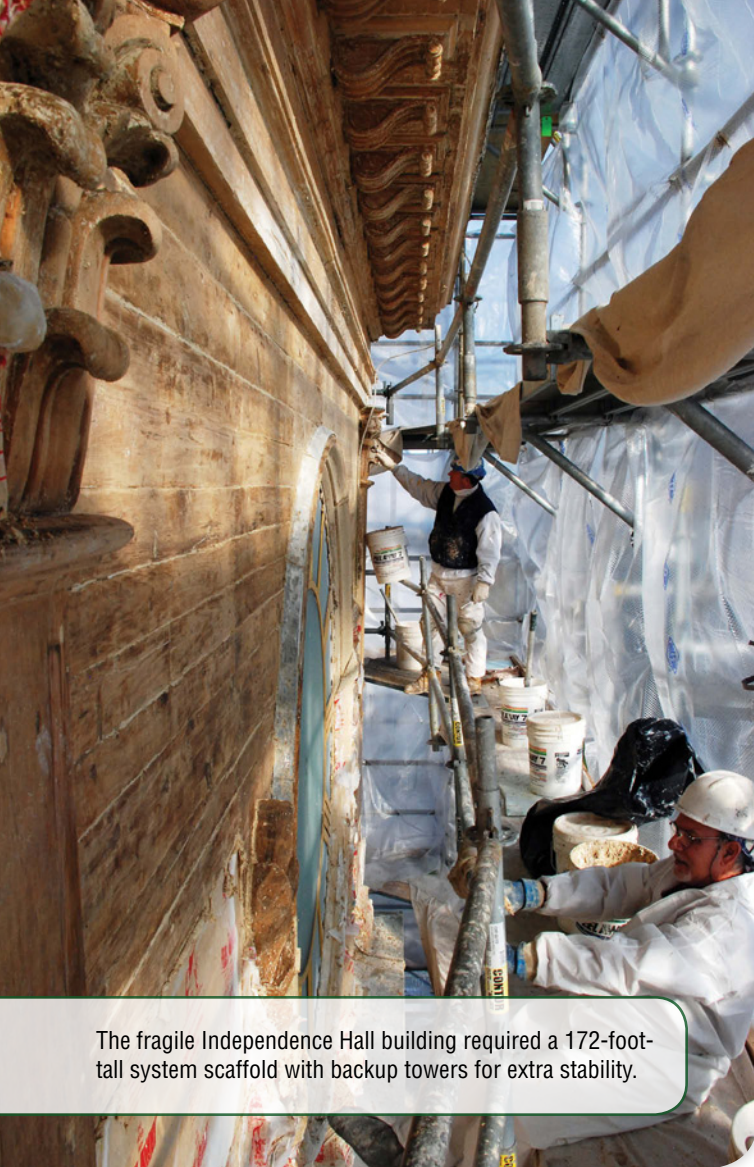
The fragile Independence Hall building required a 172-foot-tall system scaffold with backup towers for extra stability.

To do so, Superior built a 172-foot-tall system scaffold that surrounded the famous structure's clock tower. The scaffold landed on the ground and upper roof of the structure.

Bianchini noted that Superior engineers called for backup towers to add stability and limited the number of ties to the building. The scaffold accessed the stair tower up to 140 feet with a ladder scaffold completing the final 32 feet along the spire. But that wasn't all. A Betamax MaxClimber 1000 hoist provided additional access for the restoration workers and their materials. Crews installed netting and a decorative scrim (depicting the façade of Independence Hall) on all four sides.

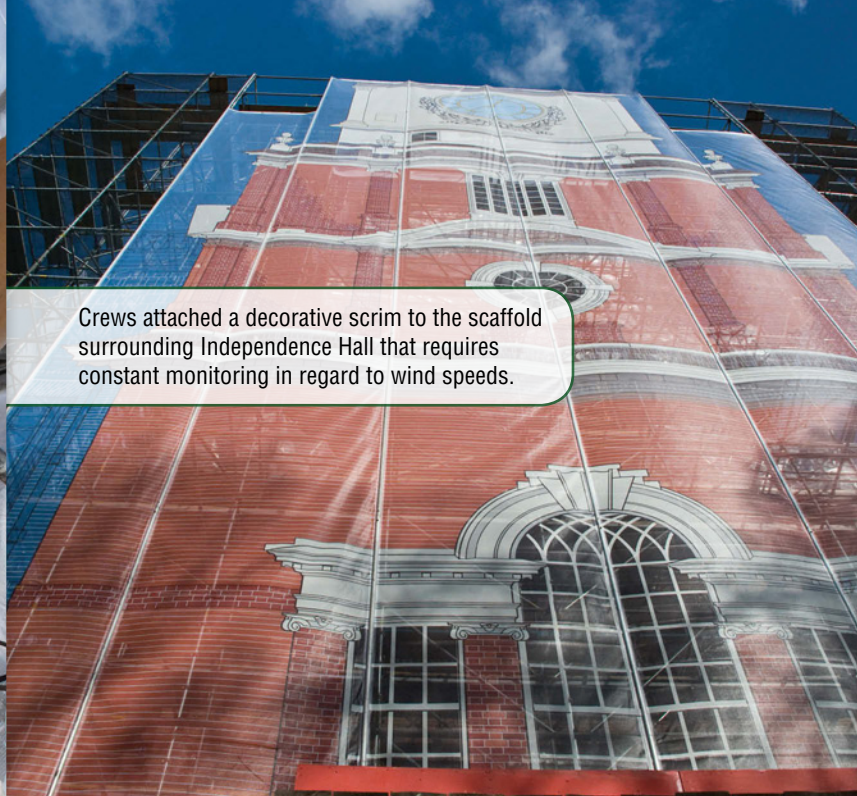
Crews attached a decorative scrim to the scaffold surrounding Independence Hall that requires constant monitoring in regard to wind speeds.

- **Scrim.** To camouflage the restoration work and allow visitors a glimpse of the building obstructed by the scaffolds, workers attached a scrim of decorative polyester panels to the access system. The scrim's 150 printed pieces, paid for by a generous donation from Friends of Independence ([www.friendsofindependence.com](http://www.friendsofindependence.com)), created a carefully crafted reflection of what the final Independence Hall would look like.

Because scrim systems can easily catch the wind when certain weather conditions develop, Superior engineered the scaffold structure to withstand excessive wind ratios. Doing so was an engineering feat considering the tremendous pressures on the structure and the need to maintain the integrity of a building that stands 12 stories tall.

For the scrim, engineers knew from the start that they faced a challenge due to strict wind-load requirements. (See boxed information, "Getting Around the Challenges," on page 21.) In fact, since installing the scrims, the rule has been that if wind speeds top 40 mph, workers have to remove the panels to

eliminate any possible harm the "sails" could create to the aged structure.

"Due to the abilities of the wood tower, we constantly monitor the wind speeds," Robinson said. "The wind has to be consistently over 40 mph (to force the removal of the scrim), but we haven't had to do that yet."
