scaffold & access magazine

# *FLYING HIGH AT 1900 RITTENHOUSE SQUARE*

MAST CLIMBERS PROVIDE  
ACCESS FOR THE  
RESTORATION OF A  
HISTORIC LANDMARK.

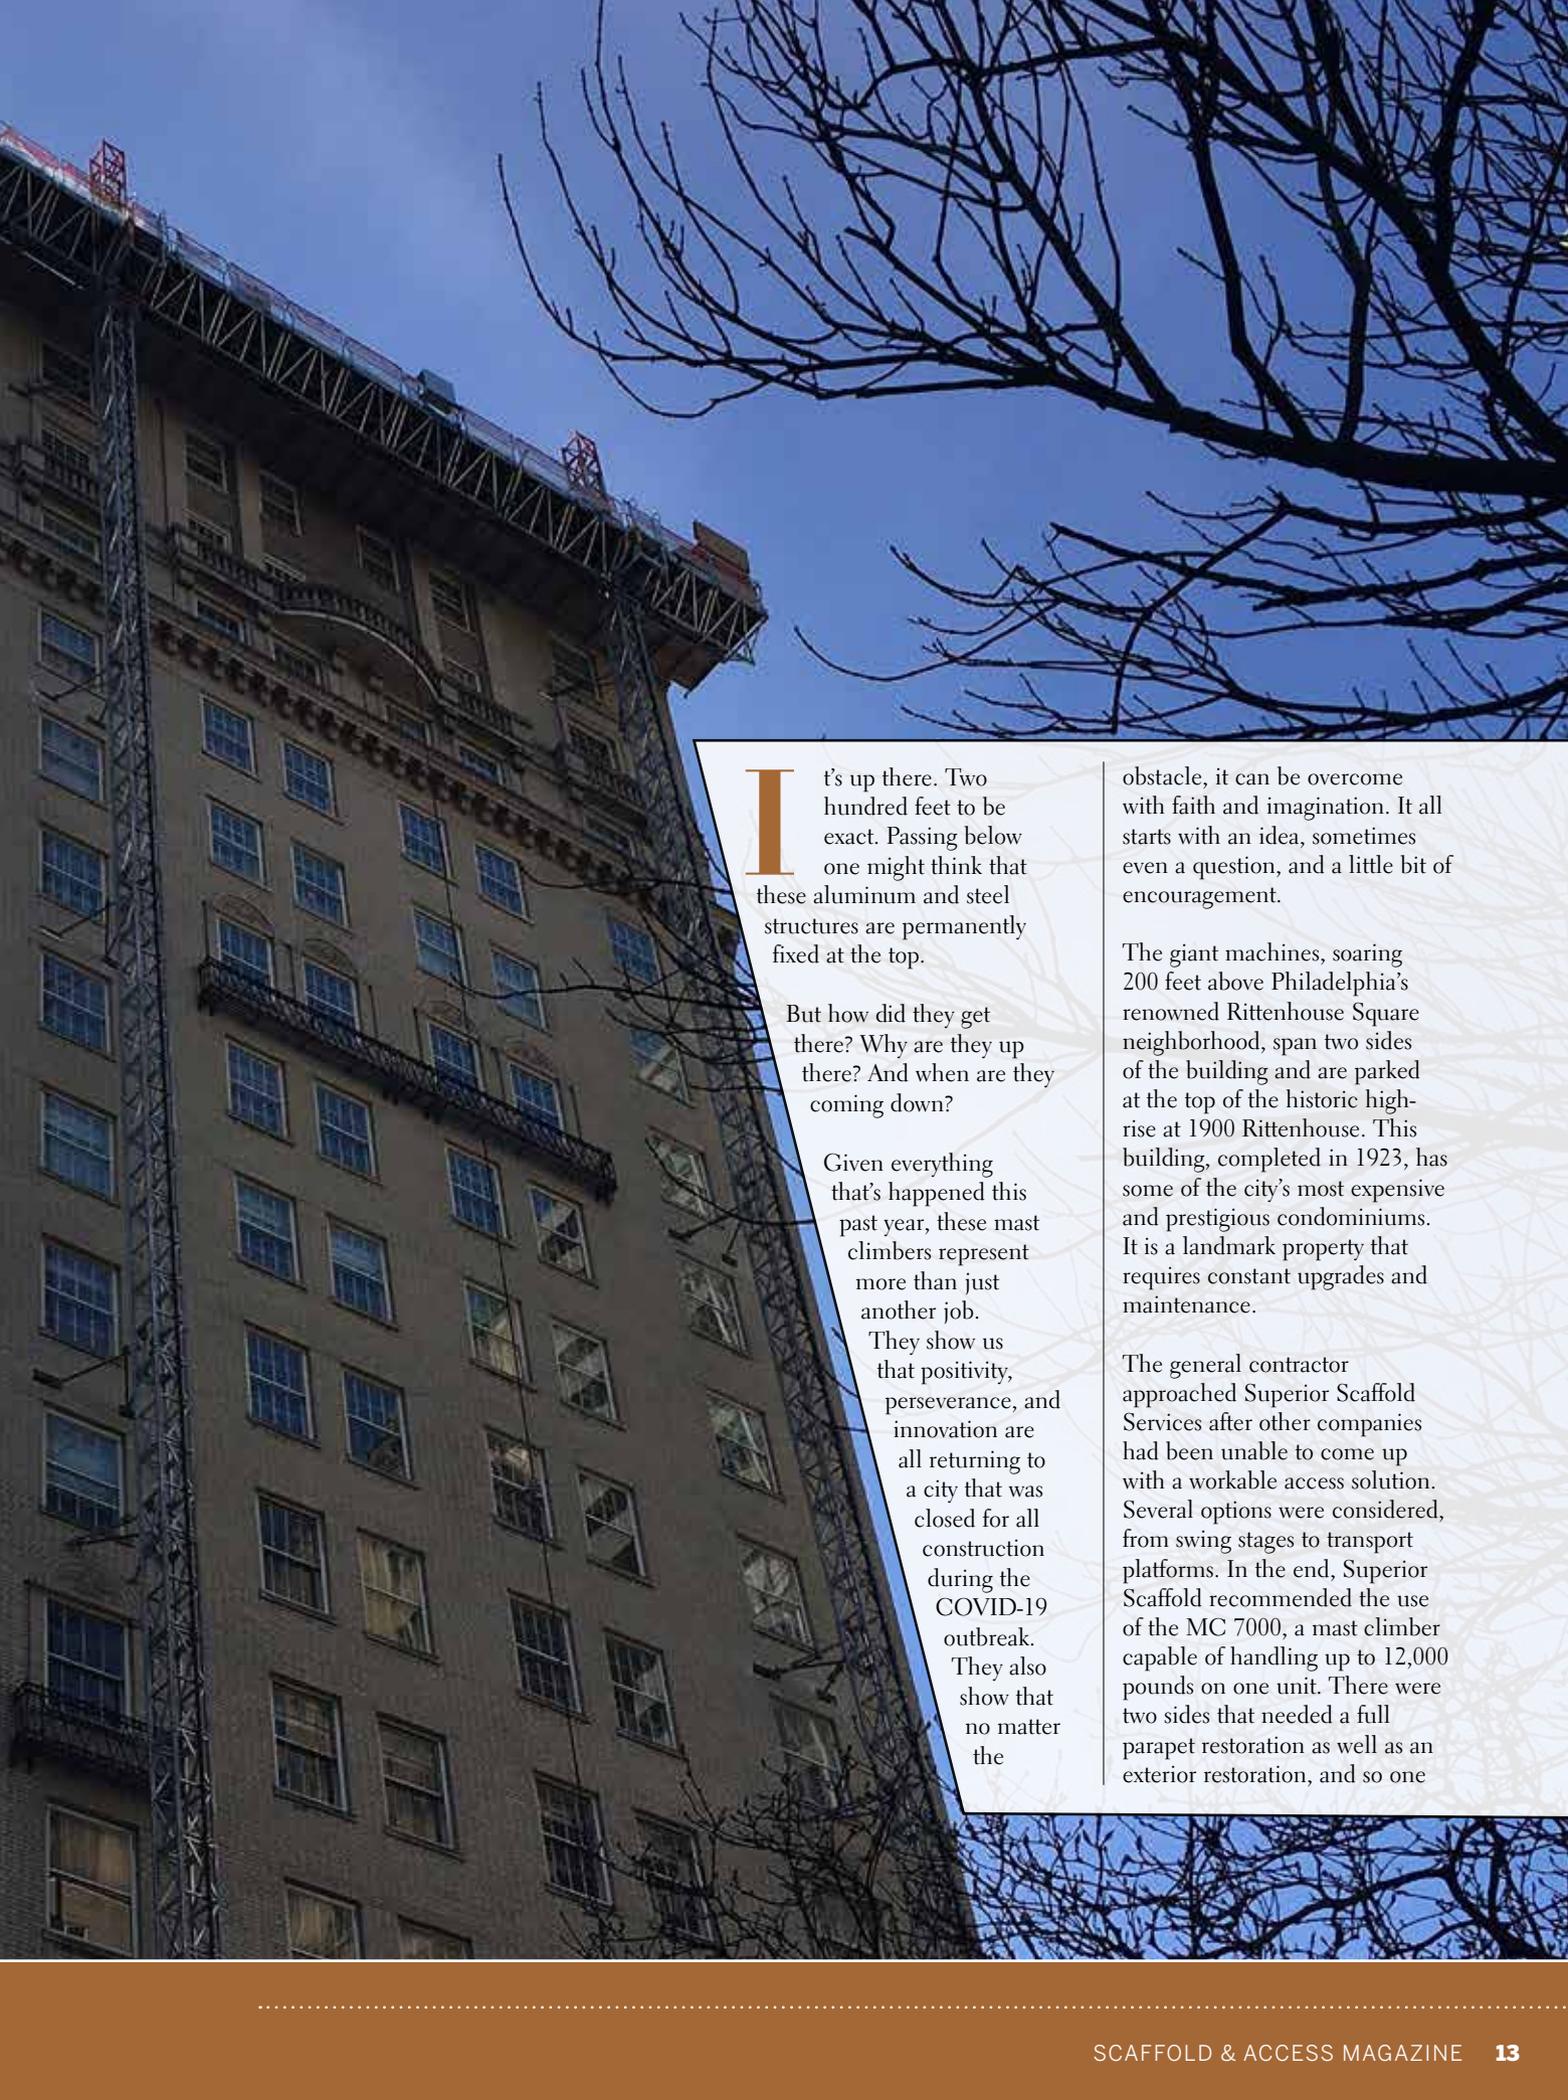
The giant machines, soaring 200 feet above Philadelphia's renowned Rittenhouse Square neighborhood, span two sides of the building and are parked at the top of the historic high-rise at 1900 Rittenhouse. This building, completed in 1923, has some of the city's most expensive and prestigious condominiums. It is a landmark property that requires constant upgrades and maintenance.

The general contractor approached Superior Scaffold Services after other companies had been unable to come up with a workable access solution. Several options were considered, from swing stages to transport platforms. In the end, Superior Scaffold recommended the use of the MC 7000, a mast climber capable of handling up to 12,000 pounds on one unit. There were two sides that needed a full parapet restoration as well as an exterior restoration, and so one

So now, soaring high over the streets and pedestrians below, sit two mast climbing units spanning the entire facade on two sides, delivering new brick and life to the aging structure. Restoration and masonry crews are currently replacing and rebuilding the aging parapet. They have to take down the old brick and replace it with new. These twin mast units can hold a great deal of weight, and because of their increased capacity fewer trips to the ground and back are necessary.
