PRESERVING HISTORY WITH PRECISION: BELLEVUE HOTEL FAÇADE RESTORATION BALANCES HISTORIC INTEGRITY AND MODERN DEMANDS

MELISSA WYATT | AROMOR MASONRY, ERIK HIGHLAND | SUPERIOR SCAFFOLD SERVICES, INC.

Project Scope: Adaptive Reuse of a Philadelphia Landmark

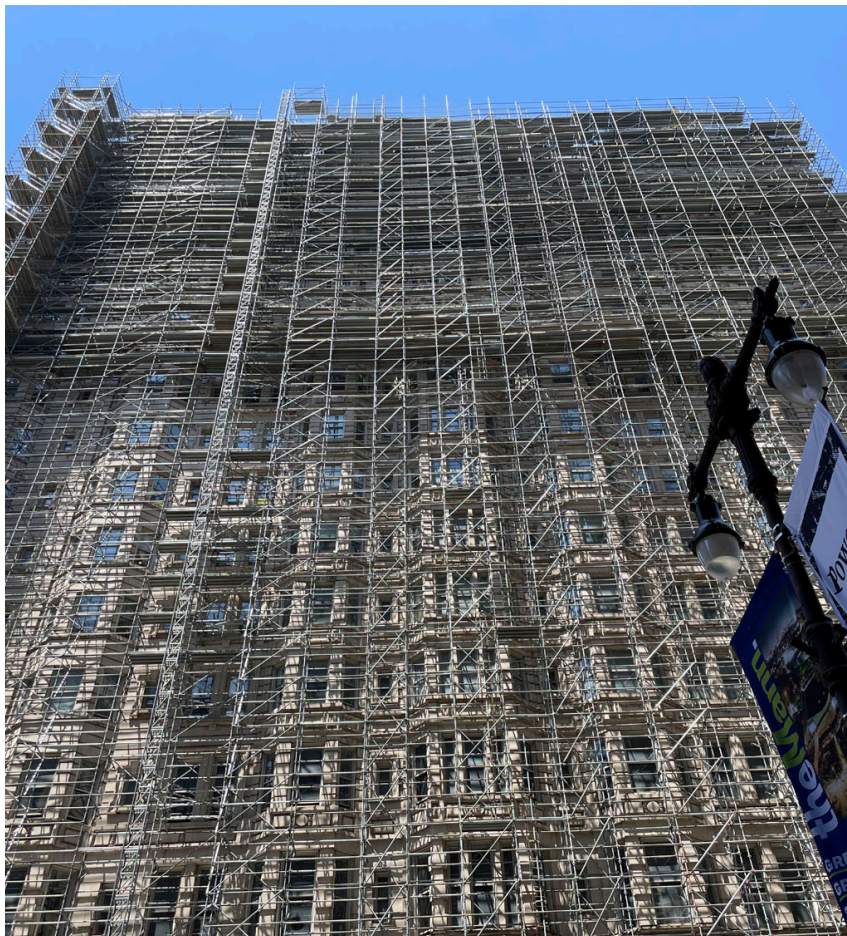
The solution? **Erect what is arguably the largest supported scaffold system in Philadelphia's recent history.** Superior Scaffold engineered and deployed a massive ground-supported scaffold that allowed teams to work incrementally across the structure's full height and width. To expedite the schedule, crews began work on one or two elevations at a time, erecting and dismantling in stages to maintain progress.

To support vertical transportation, a materials hoist was installed—an essential addition given the scaffold's 38-story reach. Load limits were strictly enforced: only eight decked scaffold levels could be in place at a time to avoid structural overload. This necessitated a phased vertical workflow, with

crews progressing in a leapfrog manner—completing five-story sections before relocating decks to lower tiers.
