History revisited

When Independence Hall needed refurbishing, Superior Scaffold Services got to work. ALH reports

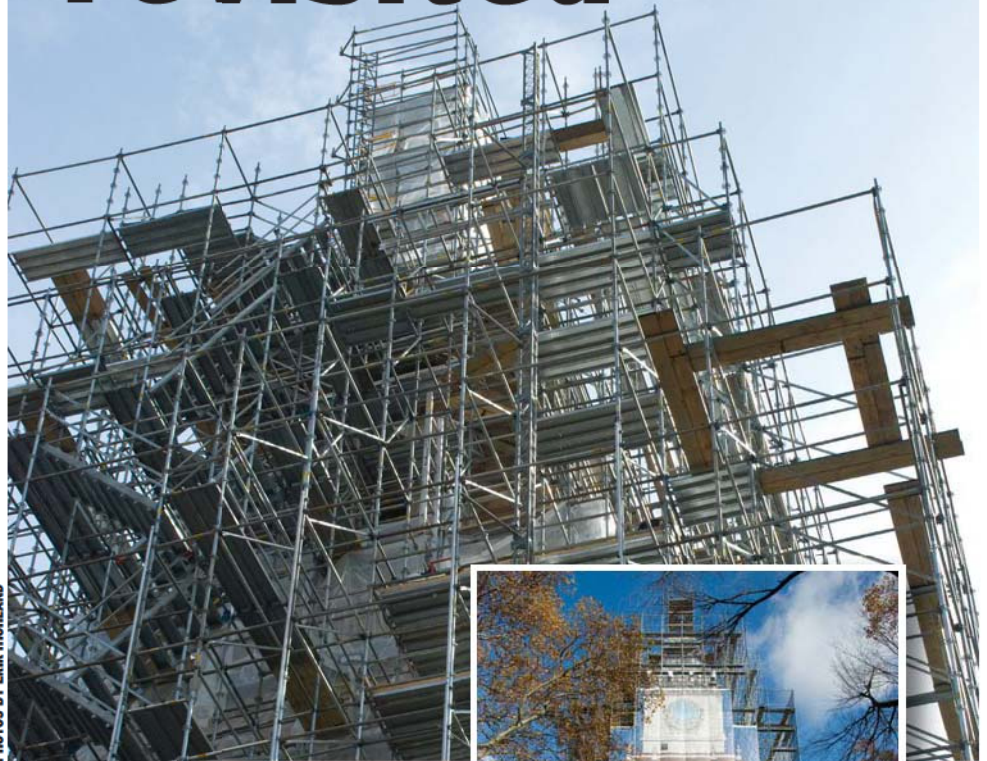
Superior Scaffold Services' design team had major challenges when it came to erecting and building the 172-foot-tall scaffold that surrounded the famous structure's clock tower. Since they could only touch the building in a few points due to the fragile nature of the structure, Superior engineers had to design the scaffold for maximum stability.

Another challenge Superior also faced was providing workers with a clear and stable platform from which they could conduct the refurbishing of the giant, glass clock faces. The scaffold was therefore wrapped around the structure continuously, which also added stability.

To meet the upper roof's load that was 40 pounds per square foot, Superior had to reshore under the roof in order to support the scaffold, which added an additional 80 feet in height. Also, the placing of the scrim was an issue because it needed to be designed so it was

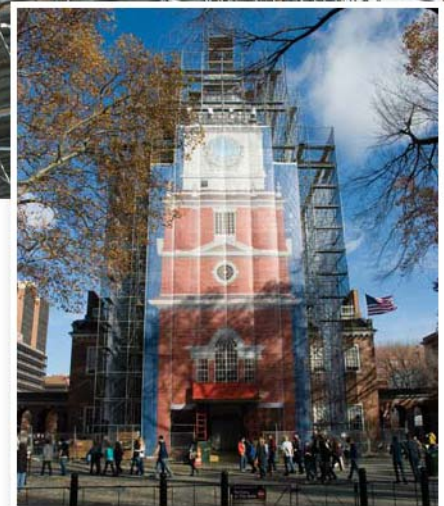
permeable enough not to violate strict wind load requirements due to the age of the building. They also widened the footprint of the scaffold to add stability.

The decorative polyester scrim, donated by Friends of Independence, was a series of carefully designed and printed panels that were assembled to look like the real Independence Hall. There were 150 single panels in all, which were labeled and graphed out ahead of time so workers knew where they had to go on the grid.

"Strapping what amounts to a sail to scaffolding around a 250 year old building is dangerous business," Robinson says. Just like a sail on a boat, the wind will pull the scrim and try to move the scaffolding in a number of directions. So, Superior Scaffold Services engineered the scaffold to withstand tremendous pressure while keeping the integrity of the building stable beneath, quite a feat for a structure that stands 12 stories into the sky.
