CONSTRUCTION TODAY

NOTHING'S EASY - SCAFFOLDING ST. PATRICK'S ROMAN CATHOLIC CHURCH, PHILADELPHIA, PA

BY ERIK HIGHLAND, MARKETING DIRECTOR | SUPERIOR SCAFFOLD SERVICES, INC.

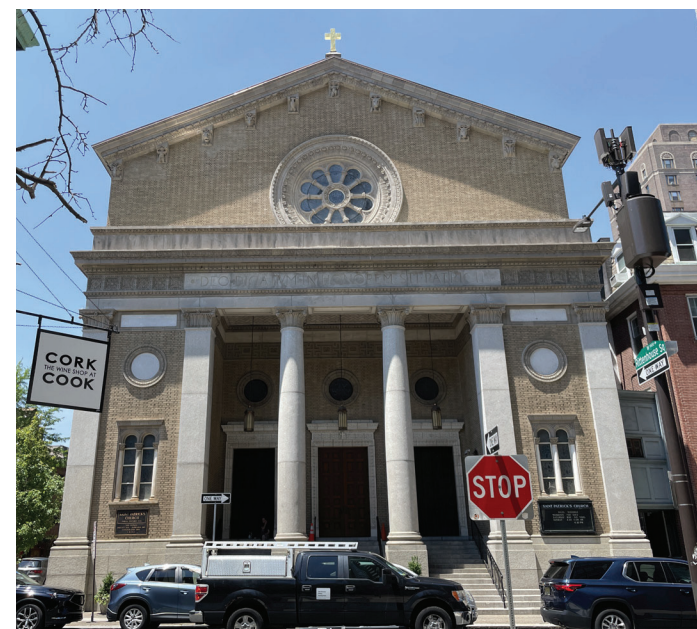
Like any project this size, it involved a mountain of moving parts. Access issues, street closures, and adapting to the changes on how best to approach this giant endeavor were some of the challenges that were a part of the project.

If you were just walking through Rittenhouse Square and saw this, you'd probably think, "wow, that's a lot of scaffolding for a renovation, but nothing special." And that's where you would be wrong.

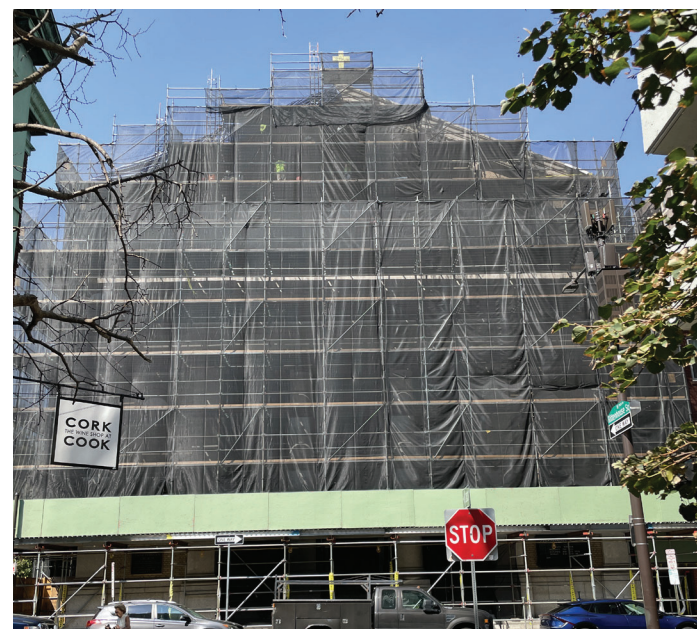
Scaffolding this intricate and a delicate project was a big challenge.

These older structures require a special touch, so that everything remains as it was 150 years ago. That means using every bit of skill and knowledge we have to not to touch the building or leave a mark of any kind on this historic church. As you can imagine, erecting scaffolding in and around all of the geometric shapes and areas, like stained glass windows, columns, decorative cornices, roof lines, etc., was a huge challenge.

Our scaffold engulfed three sides of the old church. We used containment wrap around the entire structure to keep debris from slipping out.

One of the best examples of the detail and care we took in erecting thousands of steel and aluminum parts around sensitive materials can be seen in the main entrance around the columns and around the stained-glass windows. We had to get close enough for crews to be able to clean and repair everything. Our system scaffold works best for just this type of application. It allows us to erect scaffolding at odd angles enabling us to get to hard-to-reach areas while still providing the strength and stability needed for renovation workers' safety.
